## A home in Blackhawk, Pflugerville, Texas

Sunday, August 2, 2026 · 25 photographs · Architectural asphalt shingle · next check August 2027

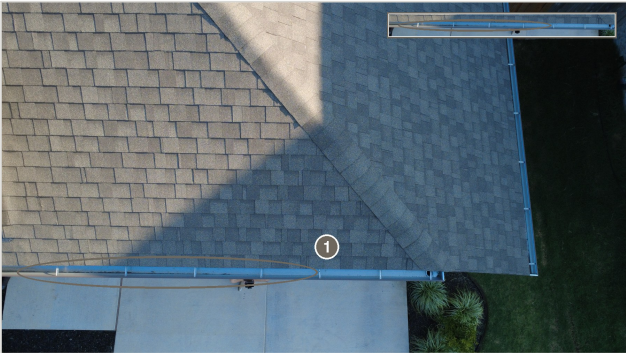
1. Rear gutter run above the back patio, from the corner to the downspout

There is a thin band of leaf litter and grit sitting on top of the gutter screens along the back patio.

WATCH

| PHOTO | WHERE | WHAT WE SAW | STATUS |
|---|---|---|---|
| | Rear gutter run above the back patio | There is a thin band of leaf litter and grit sitting on top of the gutter screens along the back patio. | ● WATCH<br>Photo 7 of 25 |

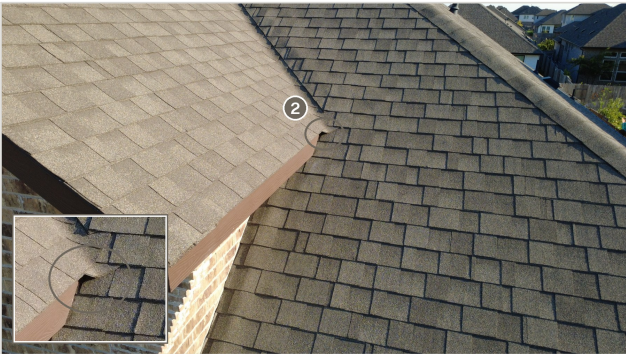
2. Where the entry gable's rake trim runs into the main roof plane

At the top end of the entry gable, where the rake trim board dies into the main roof, there is a small dark pocket under the overhanging shingle, roughly the width of a hand.

WATCH

| PHOTO | WHERE | WHAT WE SAW | STATUS |
|---|---|---|---|
| | Where the entry gable's rake trim runs into the main roof | At the top end of the entry gable, where the rake trim board dies into the main roof, there is a small dark pocket under the overhanging shingle, roughly the width of a hand. | ● WATCH<br>Photo 23 of 25 |

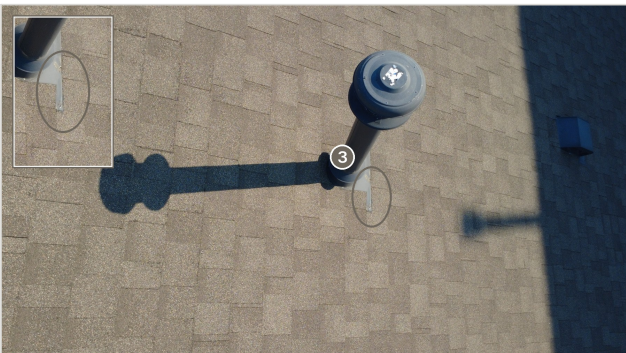
3. Plumbing vent stack on the sunlit rear plane

The bottom corner of the metal plate around this vent pipe is bent up off the shingle instead of lying flat against it.

WATCH

| PHOTO | WHERE | WHAT WE SAW | STATUS |
|---|---|---|---|
| | Plumbing vent stack on the sunlit rear plane | The bottom corner of the metal plate around this vent pipe is bent up off the shingle instead of lying flat against it. | ● WATCH<br>Photo 14 of 25 |

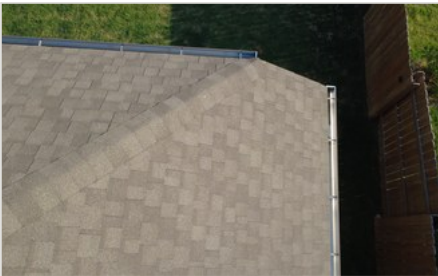
Rear plane and hip toward back fence.

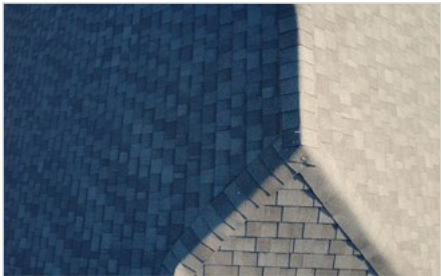
Three-plane hip junction with cap shingles.

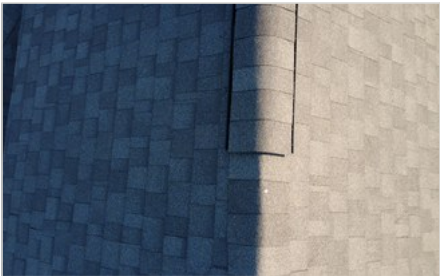
Front hip cap run close pass.
